## HLH ROTOR BLADE MANUFACTURING TECHNOLOGY DEVELOPMENT REPORT

Boeing Vertol Company  
P. O. Box 16858  
Philadelphia, Penn. 19142

September 1977

Final Report

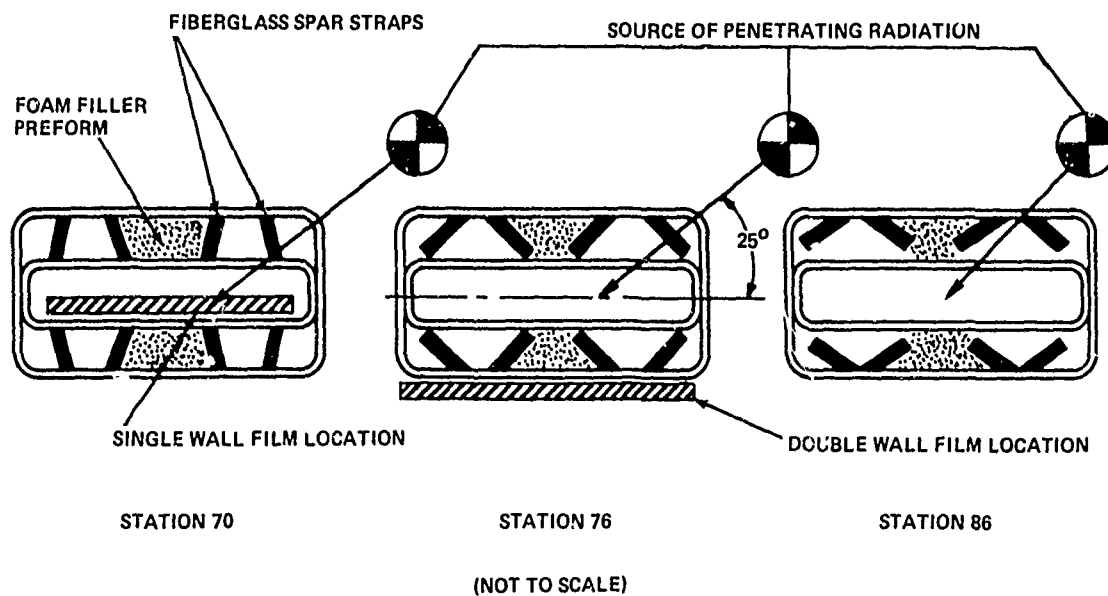
Figure 115. Typical Relationship of Fiberglass Spar Straps to Penetrating Radiation

To obtain the maximum amount of information in these areas, a number of single wall radiographic exposures were obtained by placing the film in the internal cavity of the specimen. Since the configuration of the full length spar did not allow easy access to the internal cavity, double wall exposures were obtained to compare their sensitivity to those of the single-wall exposures. Comparison of the double wall and single wall results revealed that either method is capable of detecting the presence of fiber distortion and delaminations in the spar straps, as well as cracks in the foam filler preforms. Figures 115 and 116 illustrate typical alignments of the X-ray beam, root end specimen and film location.

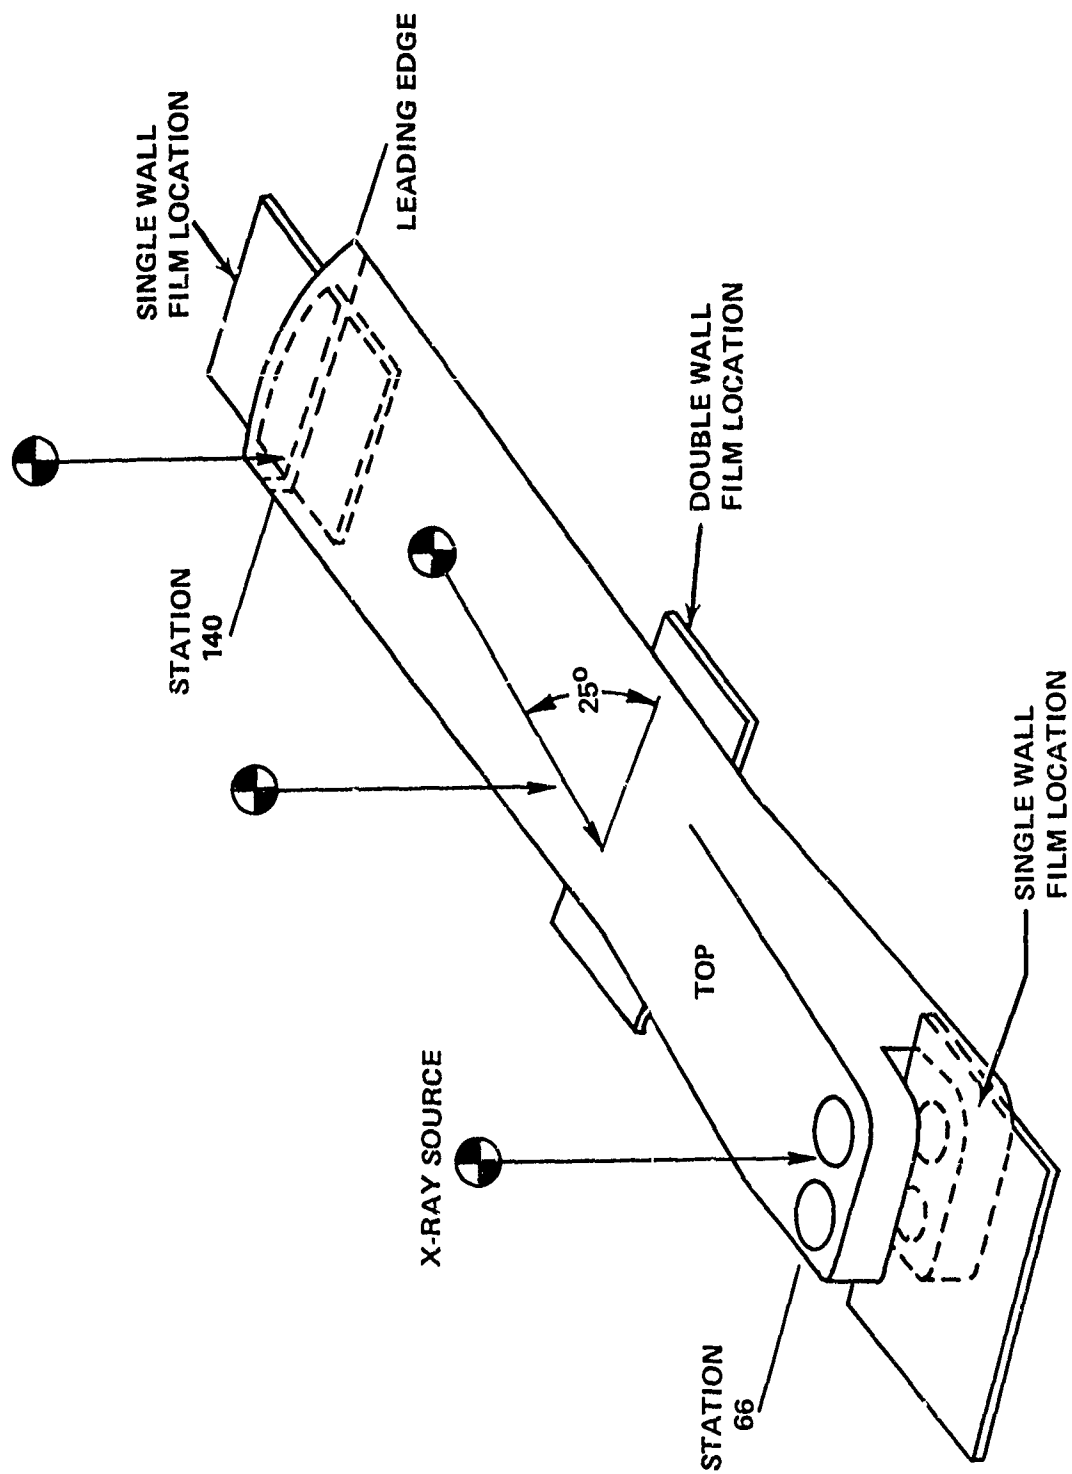
Figure 116. Typical Alignments of X-Ray Beam to Root End Specimen

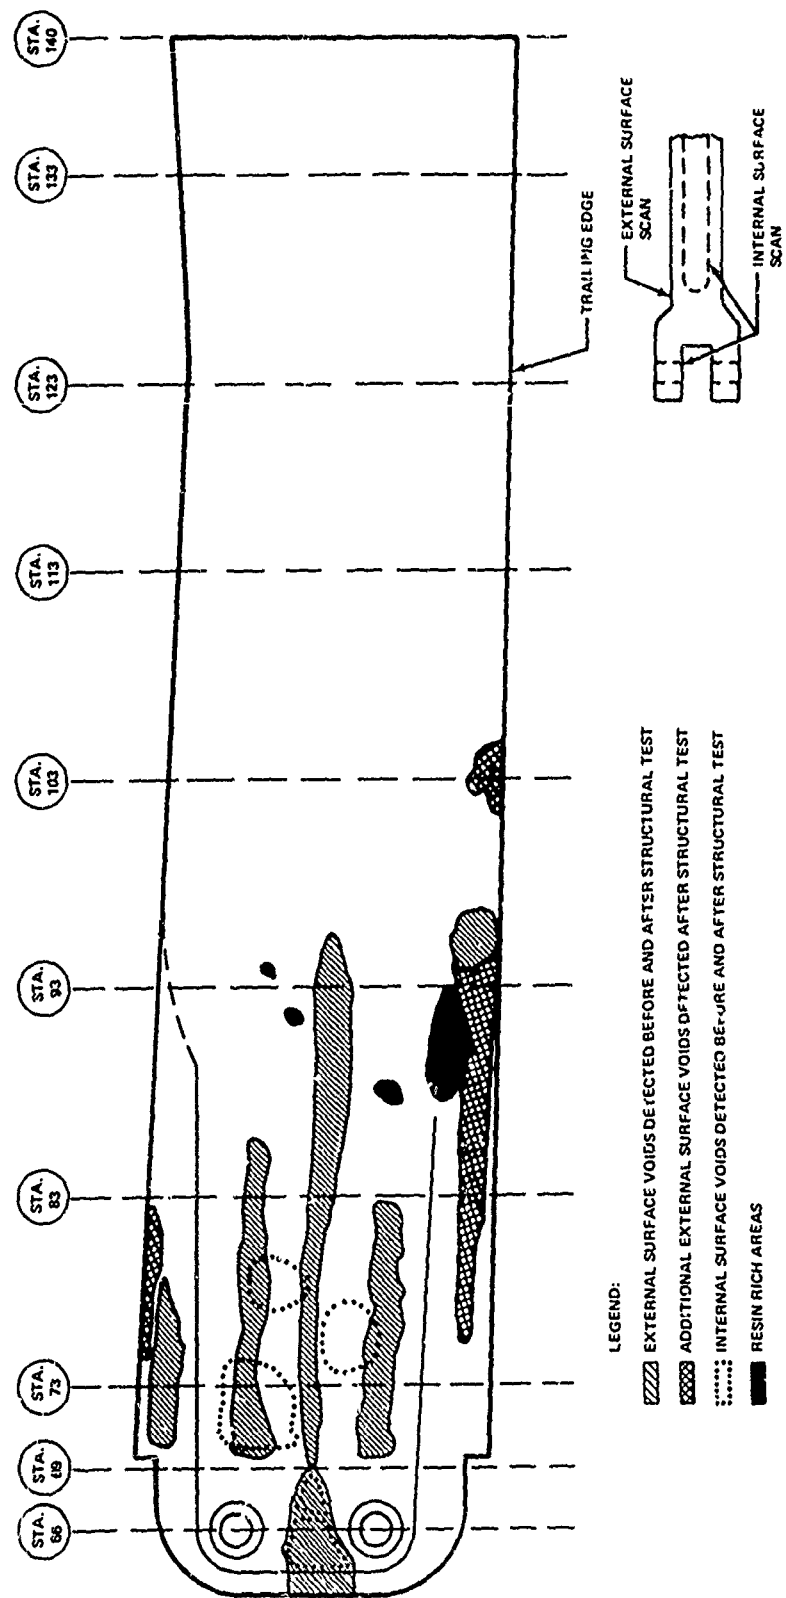
Figure 117. HLH/ATC Root End Test Specimen No. 1 (Upper Surface)

A low frequency Zetec "Sondicator", employing a dual (pitch/catch) air-coupled contact probe, was used to determine the quality level of the cross-ply outer torsion wrap to the uni-packs. Measurable surface defects were used as references for calibrating the Sondicator responses. On the basis of the responses from these areas, the entire outside surface of each specimen was inspected. All specimen areas indicating an ultrasonic response equal to or greater than those of the referenced areas were outlined on the root end specimen and are plotted in Figures 117 and 118. Ultrasonic test data taken after

the structural test program are also shown in Figures 117 and 118. Ultrasonic test data taken after the structural test program are also shown in Figures 117 and 118.

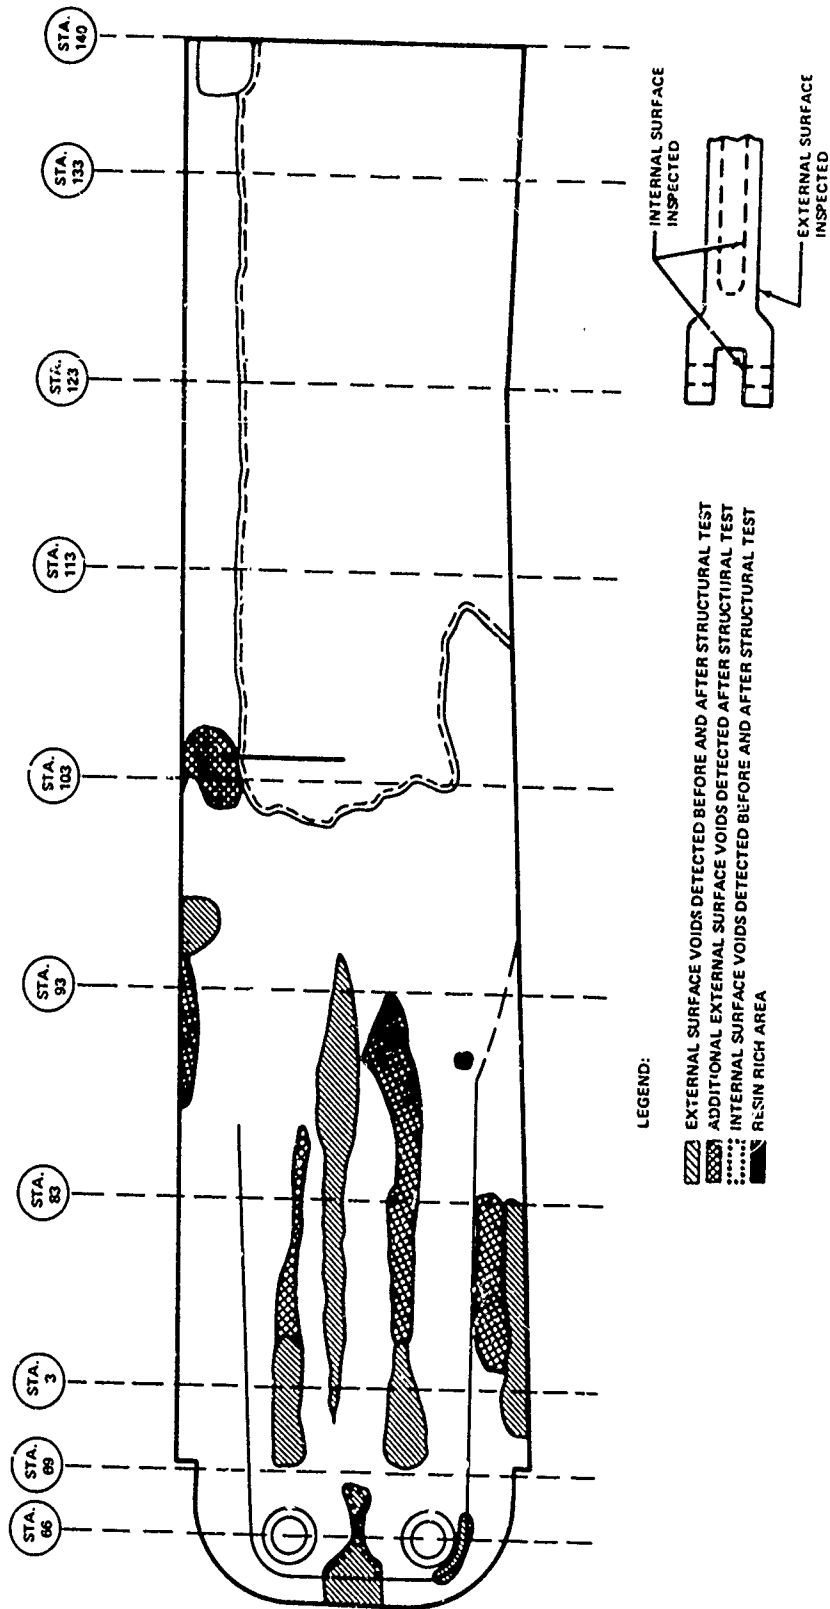
Figure 118. HLH/ATC Root End Test Specimen No. 1 (Lower Surface)

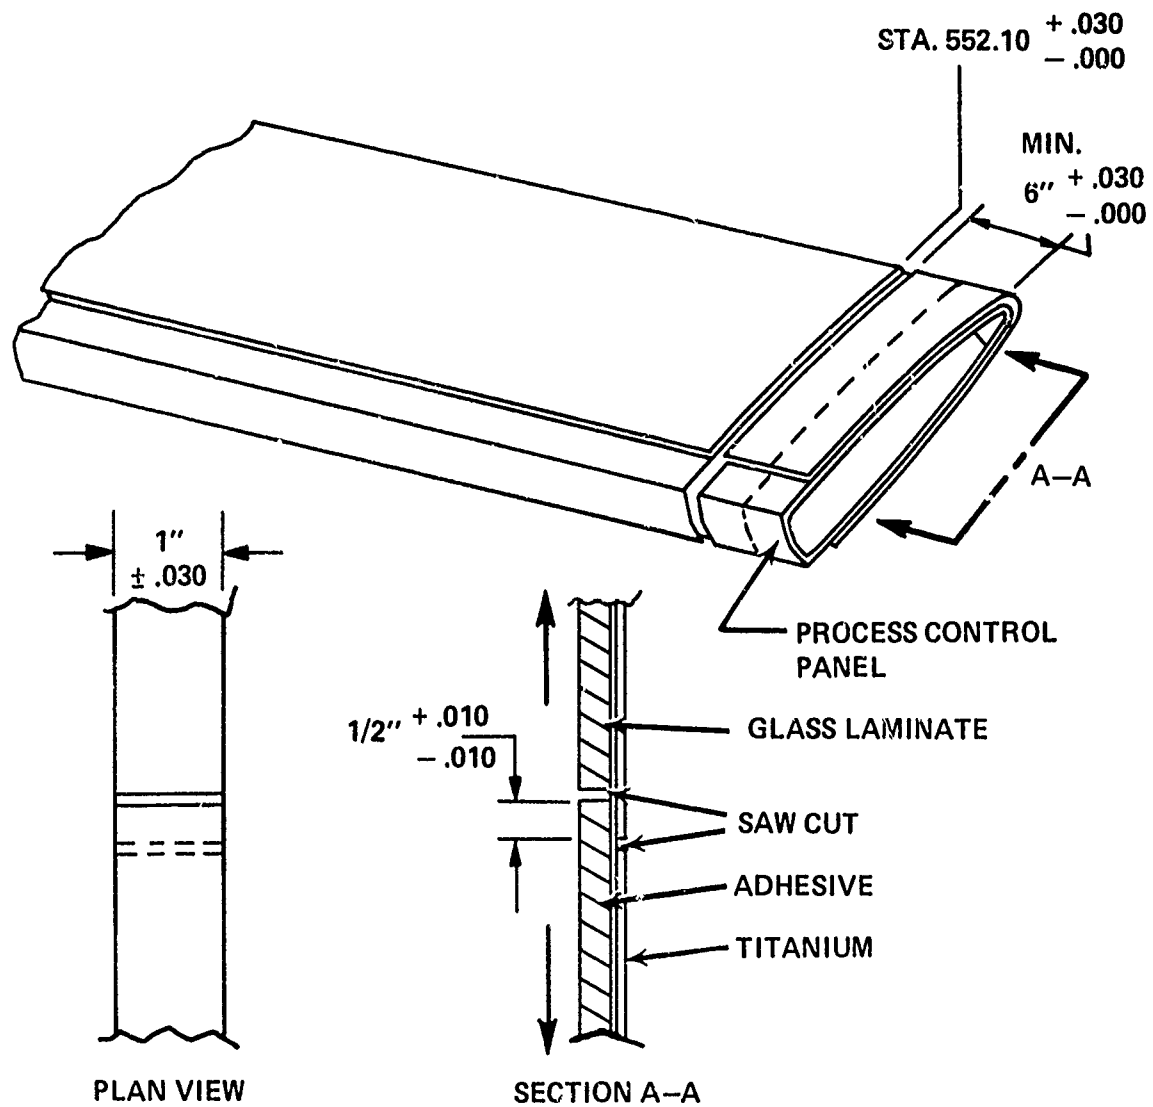
Figure 120. Process Control Panel

Process Control. The bond strength between the titanium 'C' cap and fiberglass 'D' spar was determined by performing a lap shear test using specimens taken from the Quality Assurance process control panel, which was an extension (outboard of Station 552) of the 'D' spar (Figure 120). The lap shear test was accomplished by applying a load along an imaginary straight line passing through the center of the bonded area and through the points of suspension of the specimen. Lap shear strength was obtained by dividing the applied load by the area of the overlap joint measured to the nearest 0.01 square inch. The area and the maximum stress in lbs/sq. in. of actual bond area were recorded.

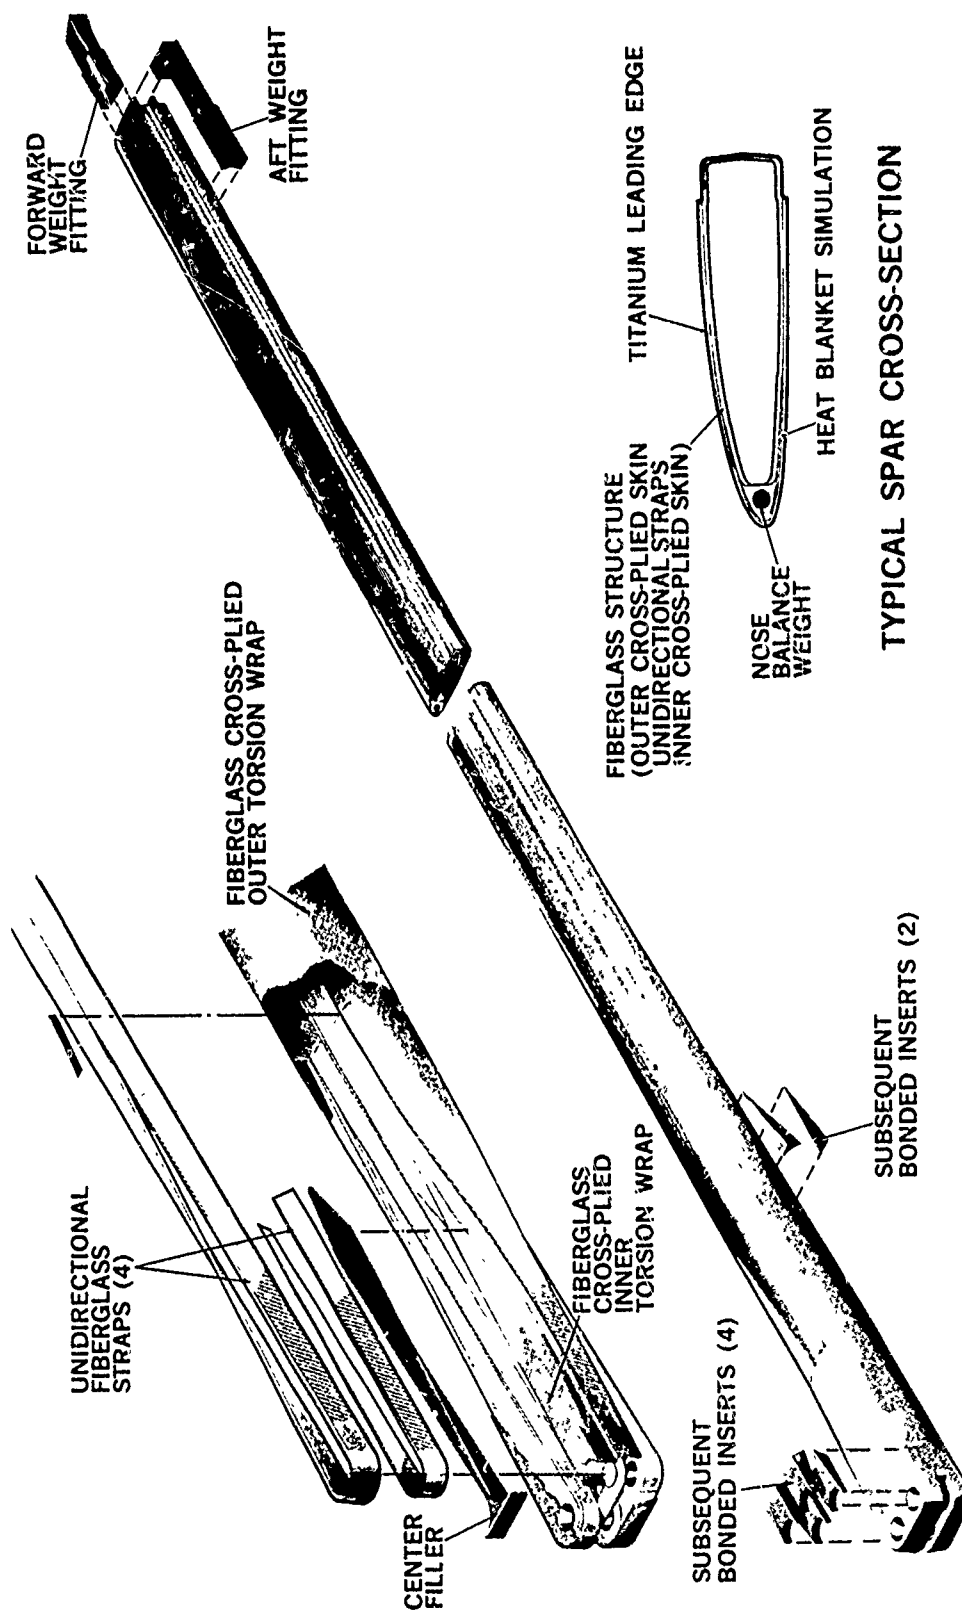
Figure 121. HLH Spar Assembly

Major Dimensional Inspections. All blade components and bonded assemblies were dimensionally inspected during blade fabrication. This included major and minor characteristics as defined in the Quality Capability Analysis and typical components as shown in the HLH Spar Assembly diagram (Figure 121) and in the HLH Rotor Blade Fabrication Sequence diagram (Figure 122).

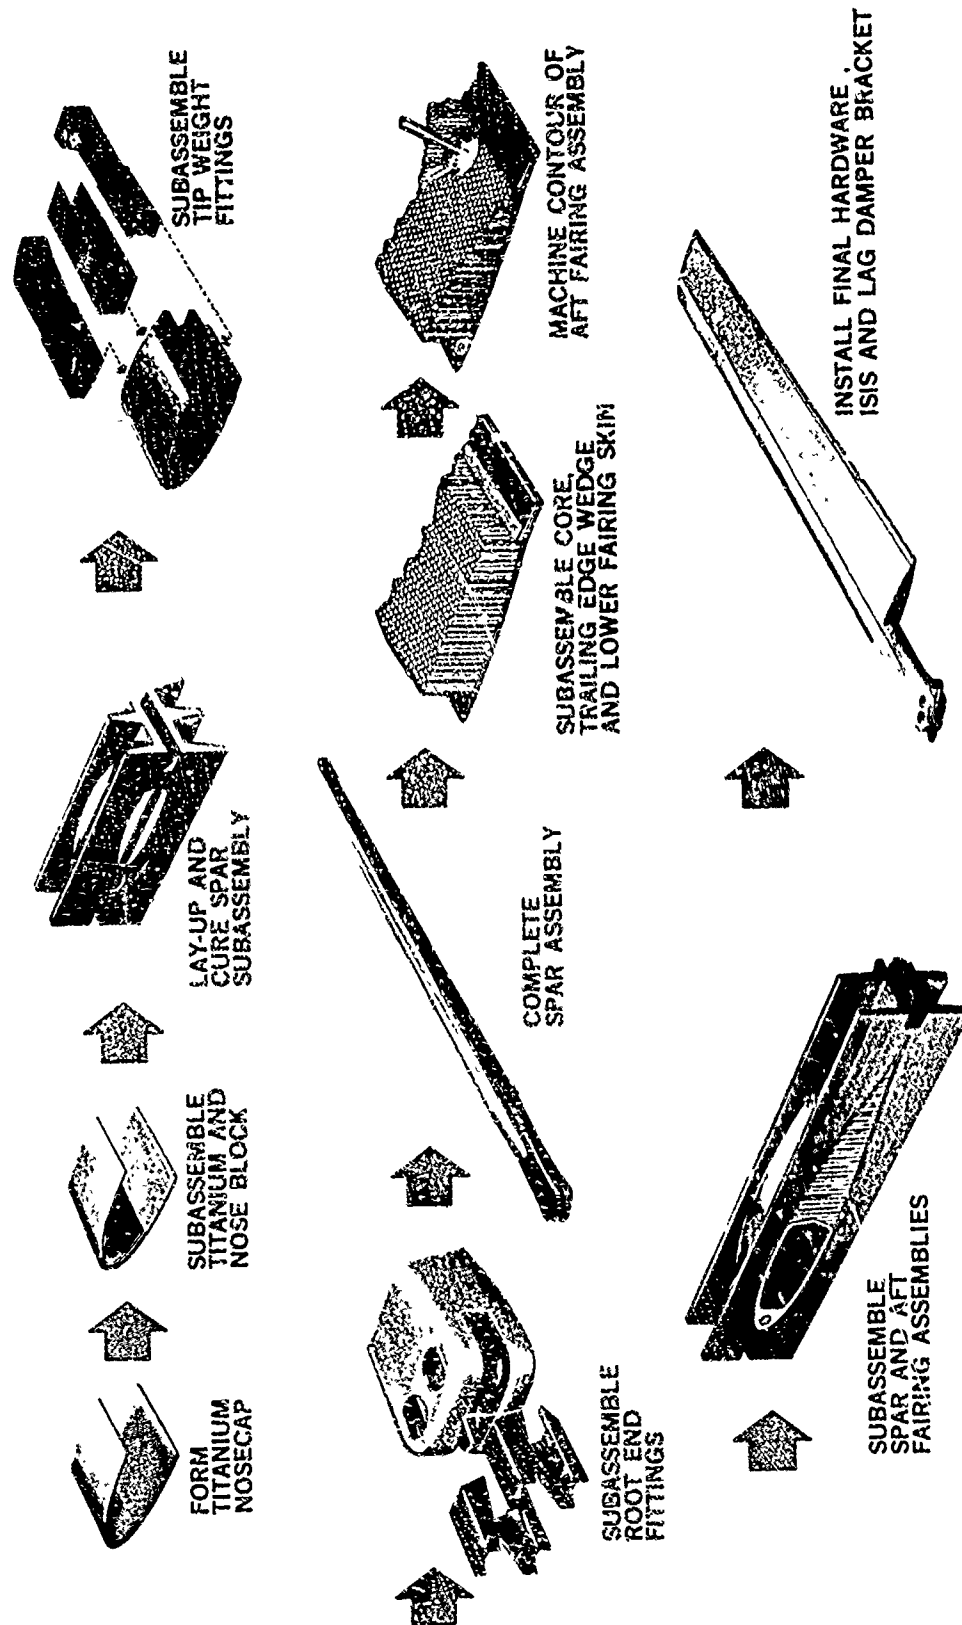
Figure 122. HLH Rotor Blade Fabrication Sequence

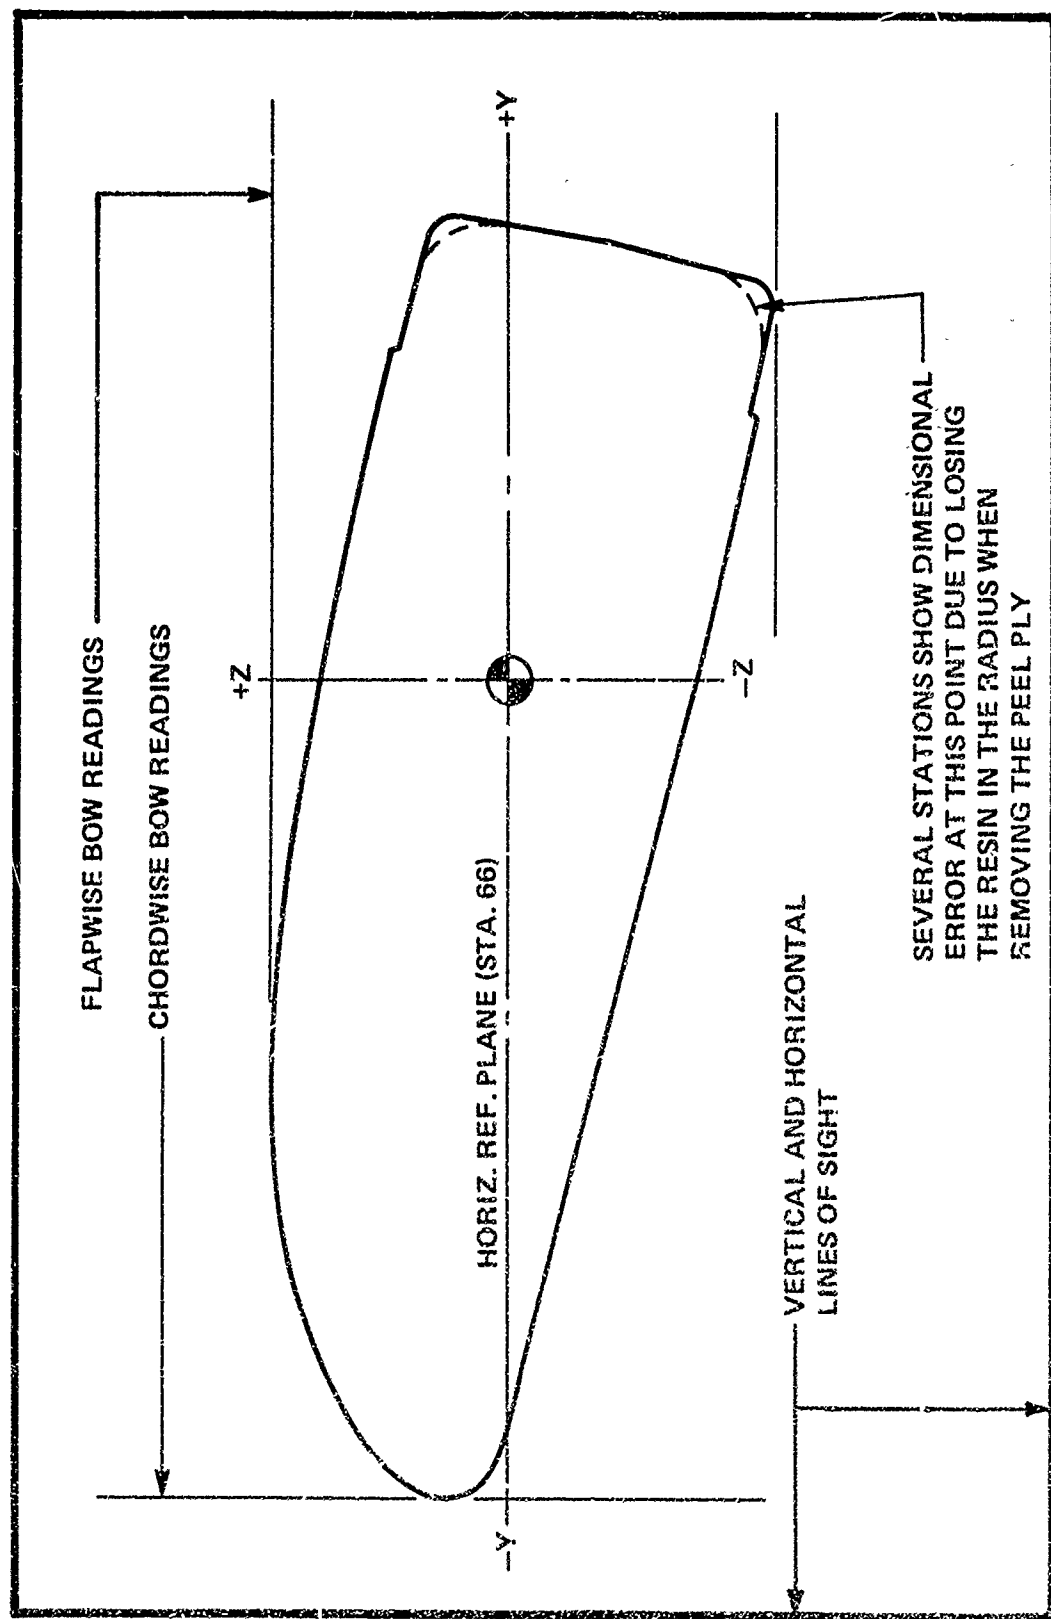
Figure 123. Spar Data Reference Lines and Coordinate Systems

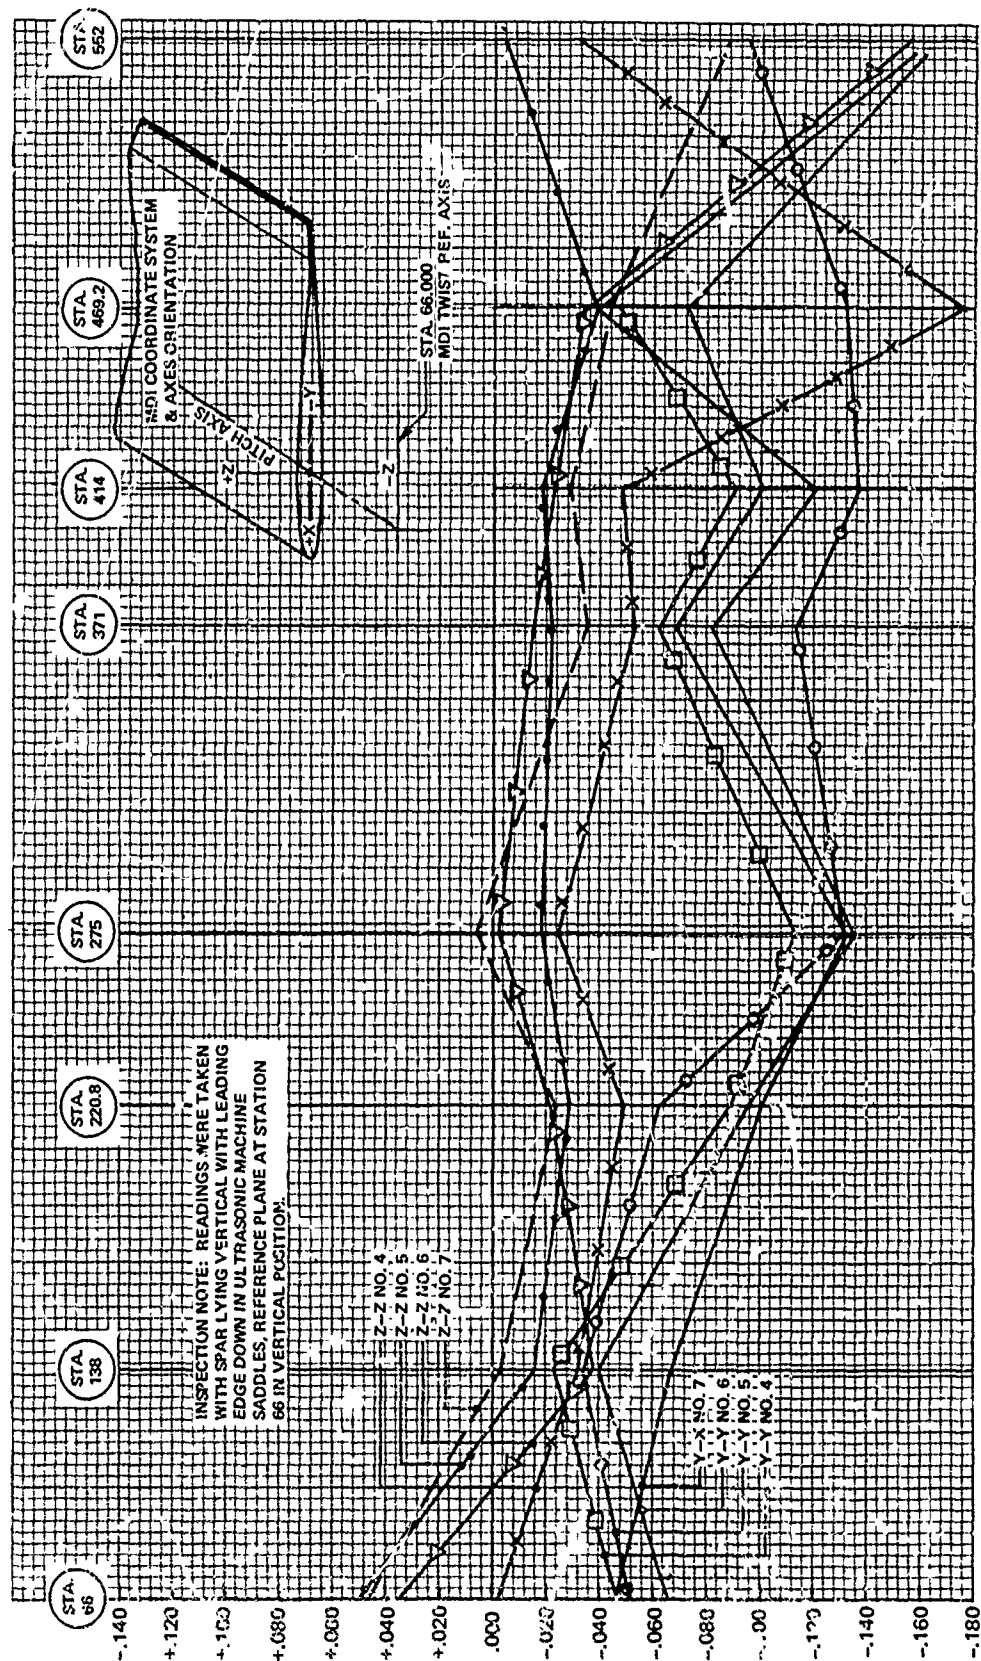
Figure 126. HLH/ATC Spar Dimensional Inspection Error Comparison Plot

A dimensional comparison of the four fiberglass/titanium D-spars used in the whirl test blades is shown in Figure 126. The graph shows deviations from the MDI requirements over the full span for each blade. The difference in the scale factors for the two axes of the graph should be noted; the horizontal axis represents the 486-inch blade span, while the vertical axis gives dimensional deviations in thousandths of an inch. The graph illustrates the general trend of dimensional errors over the entire span and indicates that these errors fall within a narrow band over the 40.5-foot blade span. Grouping of the Y-Y and Z-Z measurements at the various stations indicates good process repeatability from blade to blade.

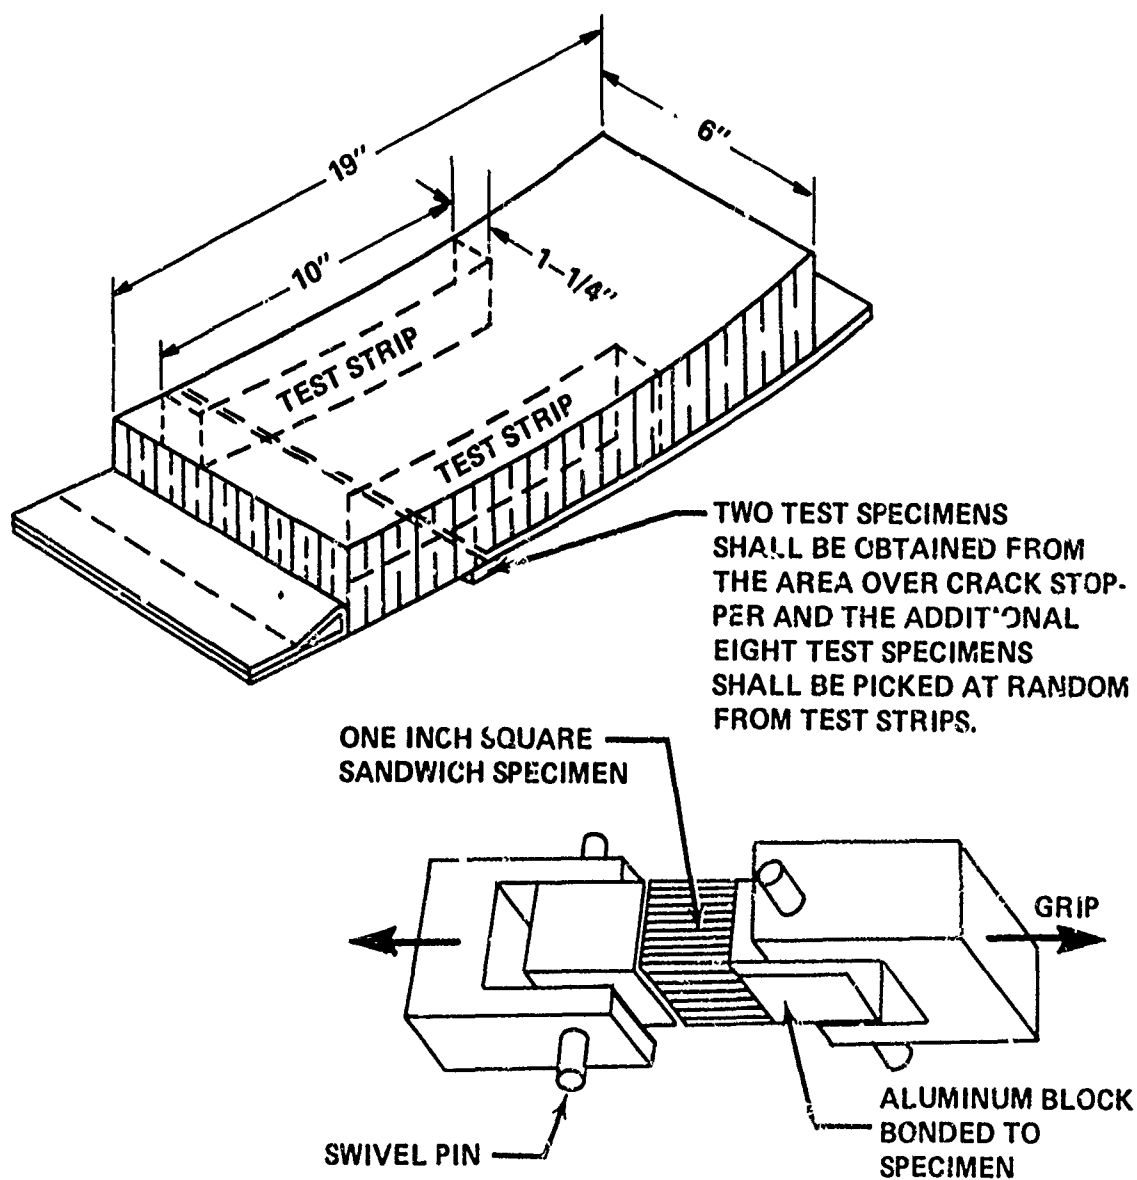
Figure 127. Section of Process Control Panel

bondline voids or node-to-node unbonds were present. Destructive tests were conducted on specimens taken from the process control panel (see Figure 127) to ensure adequate bond strength. Flatwise tensile tests resulted in core failures rather than bond failures, indicating that the bond strength was adequate.

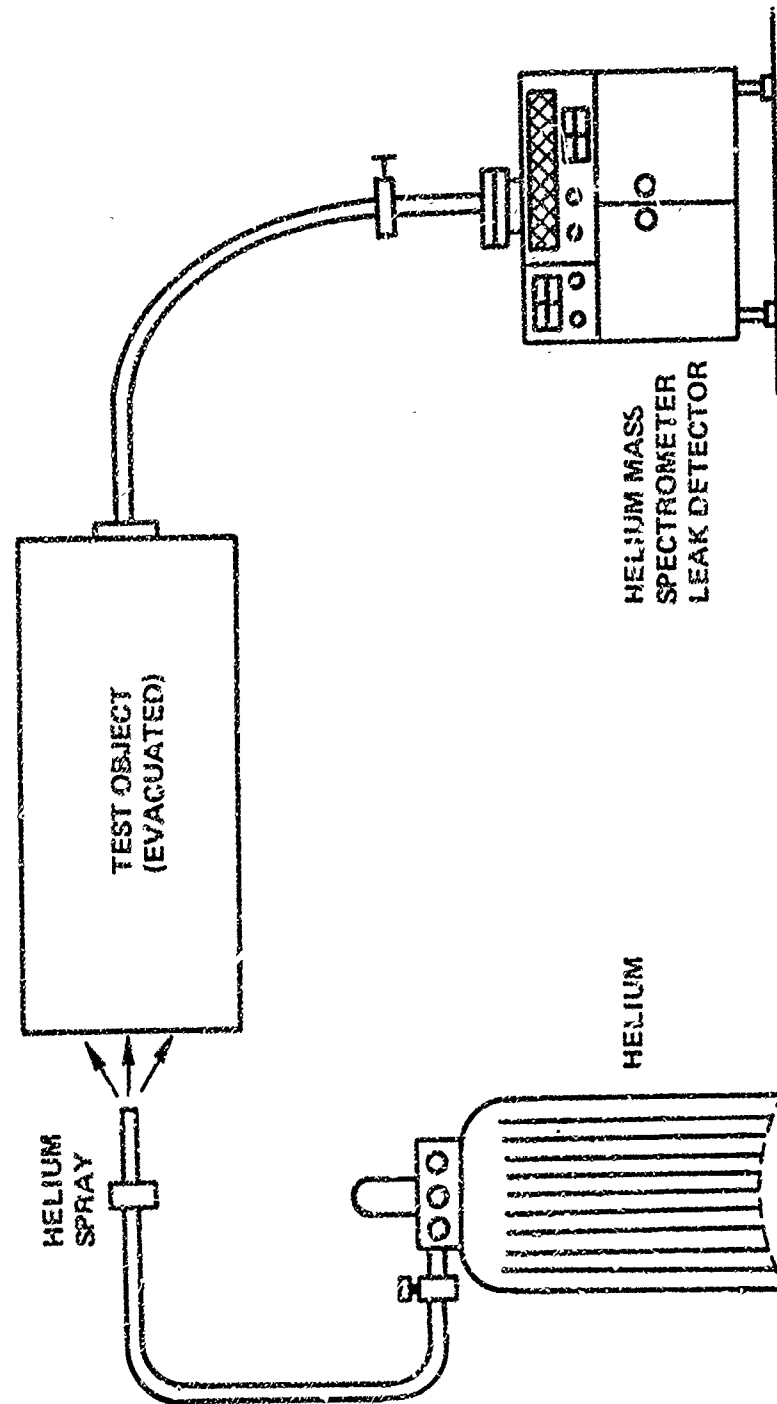
Figure 133. Evacuation Mode Quantitative Test

The evacuation mode using the helium mass spectrometer leak detector is essentially a quantitative test, as shown in Figure 133. In this mode, the test object is evacuated by the pumping system of the leak detector, and then the exterior of the test object is exposed to helium. Any helium which penetrates the test object is drawn into the detector and ionized, thereby producing a current which in turn is converted into a leakage rate. The sensitivity of this method is approximately  $1 \times 10^{-7}$  atm-cc/sec helium. If the exterior helium spray is concentrated locally to the exterior of the test object, the method also has qualitative capability. All ISIS blade components ('D' spar, evacuation valve, system indicator, seals, etc.) were subjected to these types of tests.

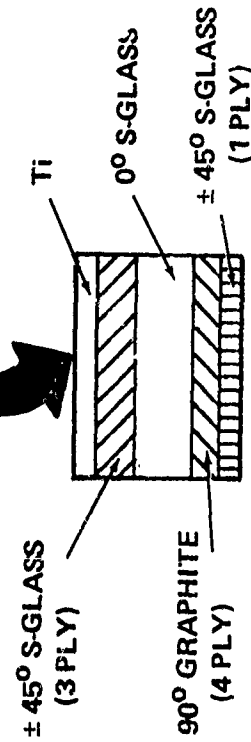
- Increase spar wall thickness with 2 ply of cross-ply S-glass and 4 ply transverse graphite (4 pounds per blade).
- Build-up replaces the honeycomb bulkhead (1.5 pounds per blade).
- Change from bulkhead to lay-up reduces fabrication cost and complexity.

Figure 136. Spar Improvements

ATC testing has revealed that the spar wall in the outboard area (Stations 569 to 552) requires additional stiffening. The modified design adds more fiberglass material to the spar straps and extends the graphite lay-up to the outboard section.

Tooling mylars and templates will be altered to reflect the changes shown in Figure 136.

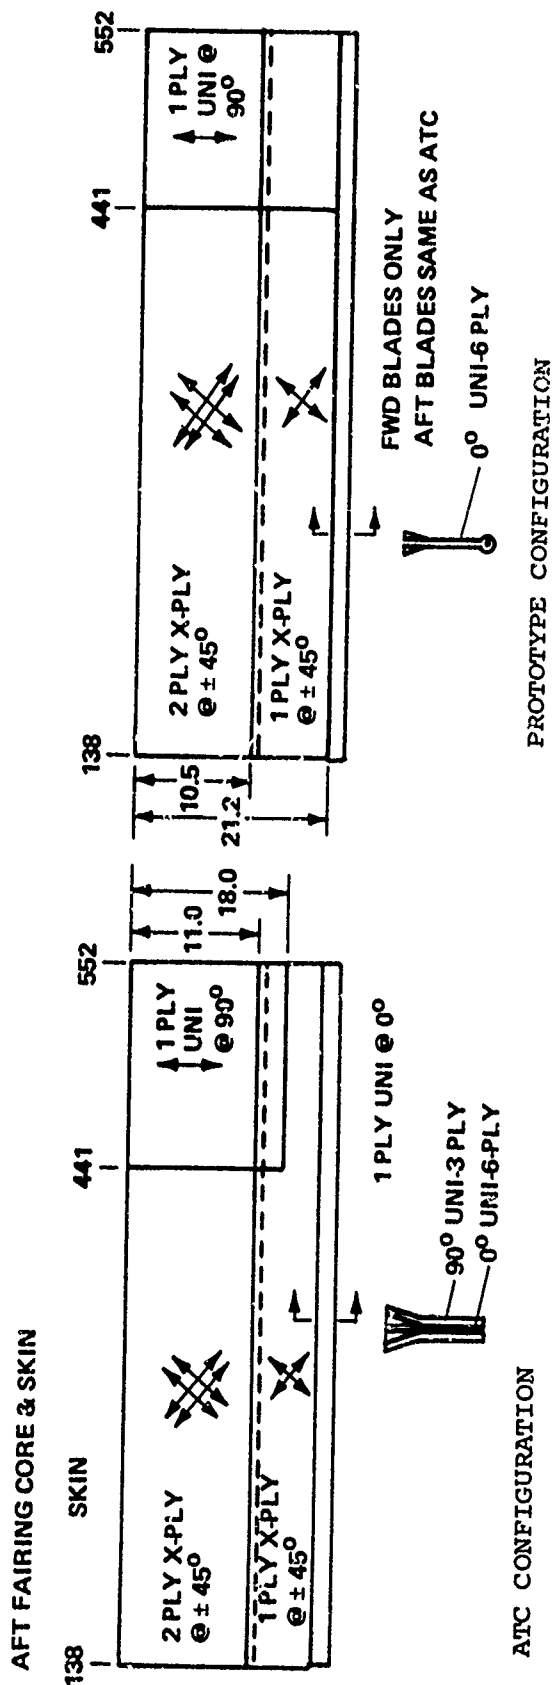
Figure 137. Aft Fairing Skin Changes

- Skins cracked during final cure due to:
  - Thermal condition
  - Pressure necessary to deform core
- Cracks only occurred in 3 lb/ft<sup>3</sup> density region where 90° material terminated.
- All 90° material in T/E wedge is cured with basic wedge. Voids occur during subsequent operations if tolerances shift beyond expected range.
- Extended 90° uni to T/E wedge.
- Shorten inner skin by 0.5" to have core splice and uni 0° rip strip coincide.
- T/E wedge will have all 90° material added to fairing in subsequent assemblies for additional tolerance (fwd only)

On three of the seven blades fabricated, localized skin cracks were encountered. The fourth blade was the first that experienced severe cracking. However, during the resultant investigation, evidence of crack initiation was also noted on blade numbers 1, 2, and 3, but to a very minor degree. To resolve this problem, a number of the curing operations were changed on the next blades. In each case, the cracking was reduced but not eliminated. The problem source has now been identified, and a fix will be incorporated into the prototype blades.

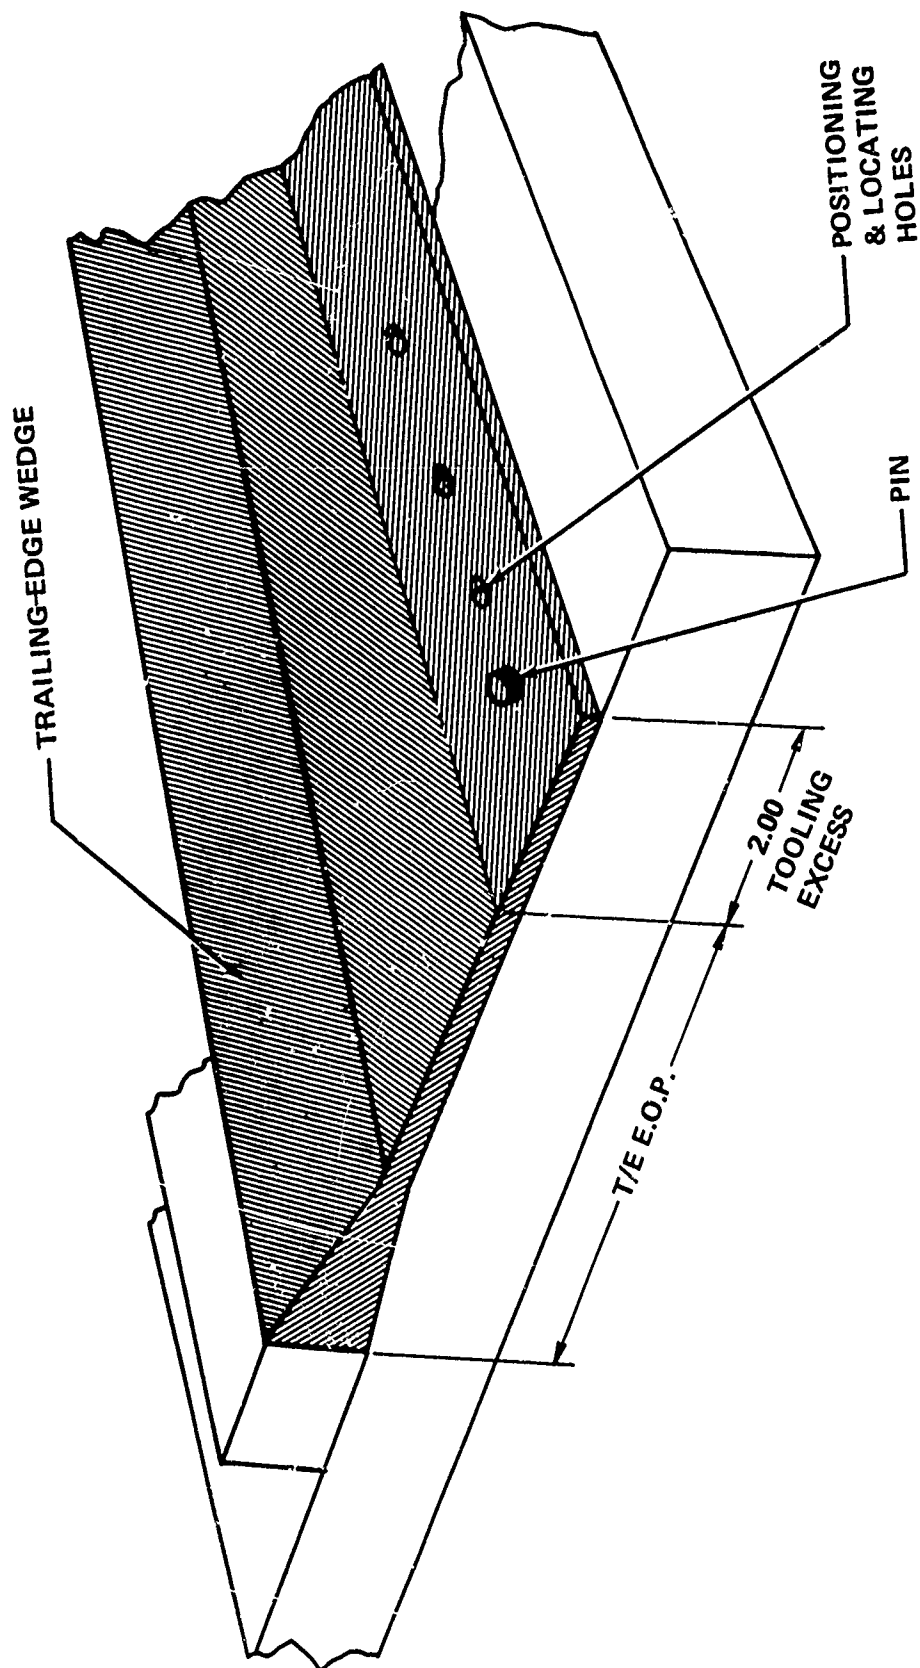
Figure 140. ATC Trailing-Edge Wedge

The ATC Trailing Edge Wedge was fabricated with 2 inches of excess material or selvage on one side; a series of  $\frac{1}{4}$ -inch diameter tooling holes were drilled in the selvage (Figure 140). The holes were used primarily for locating and holding the wedge in proper chordwise location during wedge-to-core and core-to-skin bonding operations, and final bonding of fairing to spar. The tool locator holes, in addition, were also used for locating the Nomex honeycomb core during machining of the upper airfoil contour.

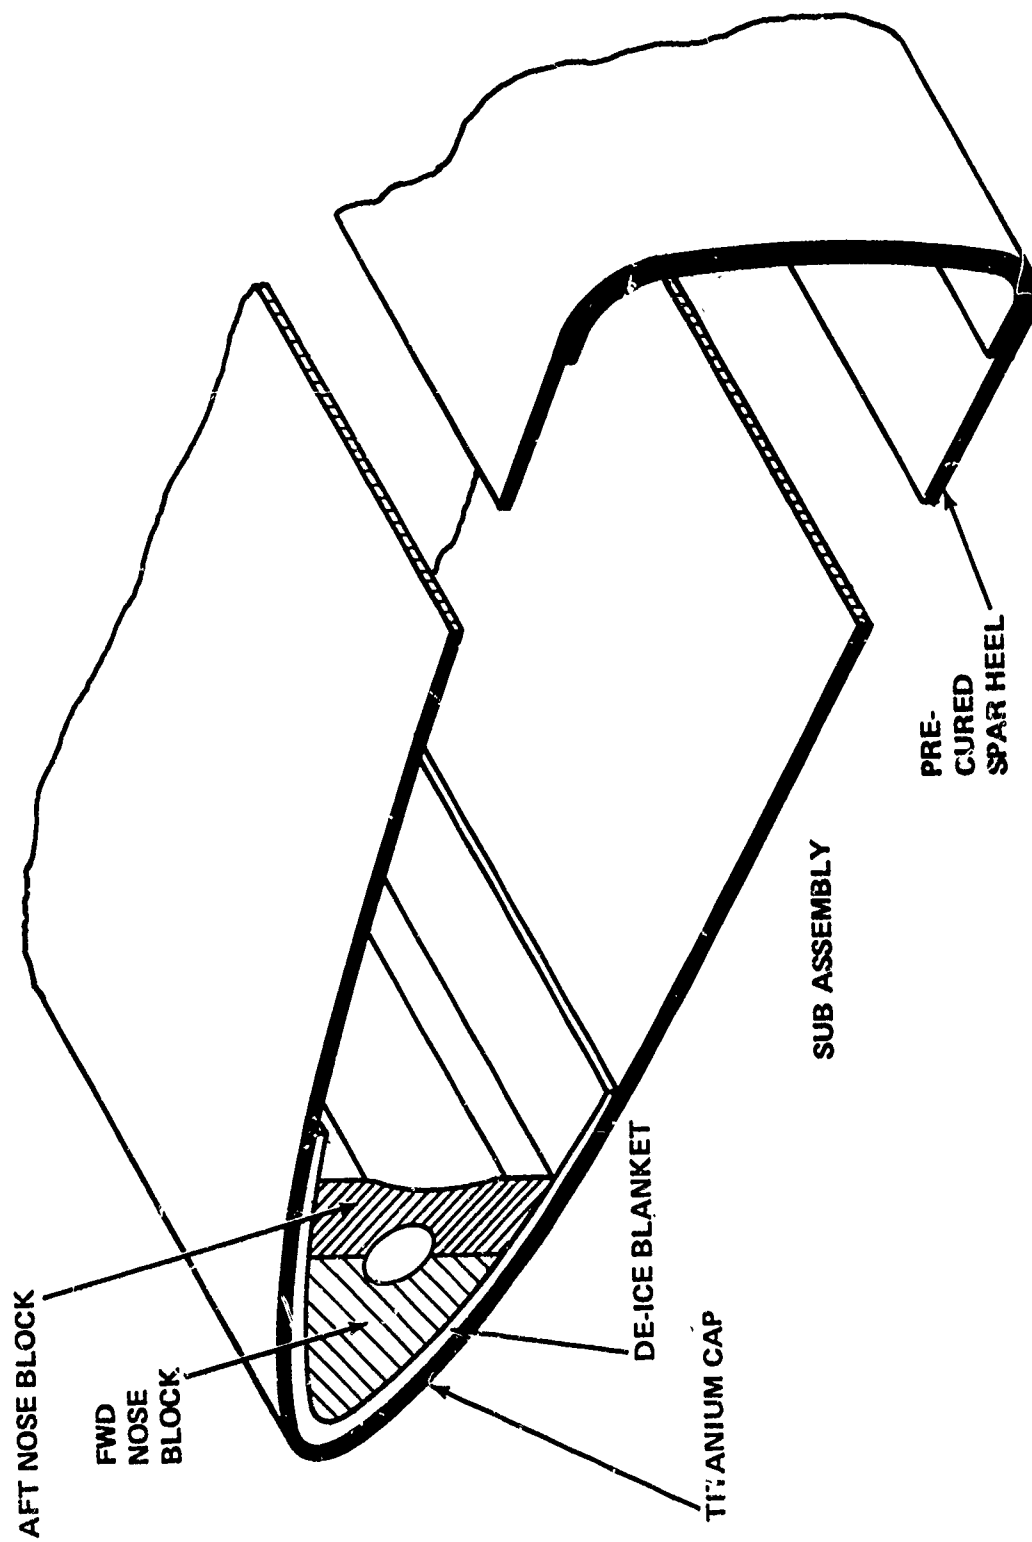
Figure 143. Pre-Cured Spar Heel

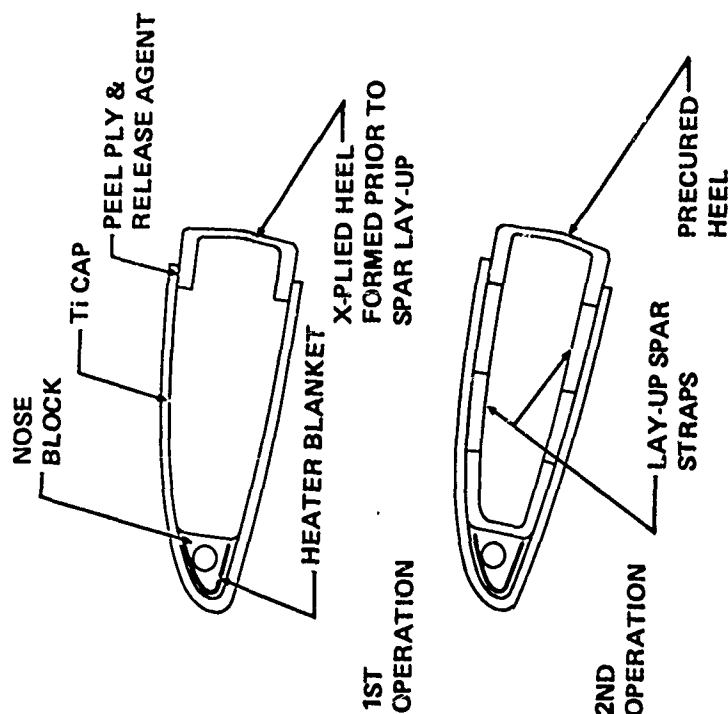
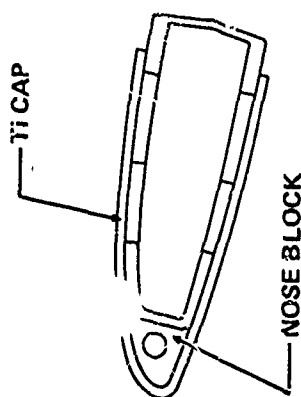
Figure 144. Pre-Cured Heel Lay-Up

#### PROTOTYPE CONFIGURATION

- Pre-cured heel which simplifies the spar assembly and insertion into the tool, eliminates the potential of any skin wrinkling at the critical heel.
- Eliminates the possibility of ISIS leakage due to resin starvation.

HEEL FORMED DURING LAY-UP OF SPAR

SPAR LAY-UP ONLY

- Lay-up of spar and assembly for a single co-cure of titanium and glass can result in wrinkles in spar heel which may be unacceptable for flight aircraft.
- ISIS leaks originate from apex of heel and require a secondary sealing operation.

The heel of the spar (section aft of the titanium nose cap) is subject to distortion during lay-up and loading into the spar BAJ. Care must be exercised to prevent or eliminate any wrinkling of the fiberglass material. To eliminate wrinkling experienced on ATC blades and to provide an improved, lower cost manufacturing approach, a pre-cured heel test spar (Station 372 to 469) has been made. Refer to Figures 143 and 144). The heel of the spar is cured as a separate detail and then bonded into the spar during spar cure. This test specimen was successfully formed.
